‘Retrofit and the Niddrie Road Tenement’

12th Scottish Empty
Homes Conference
01.03.23

Niddrie
Road
Case
Study

Tenement EnerPHit Passivhaus Retrofit

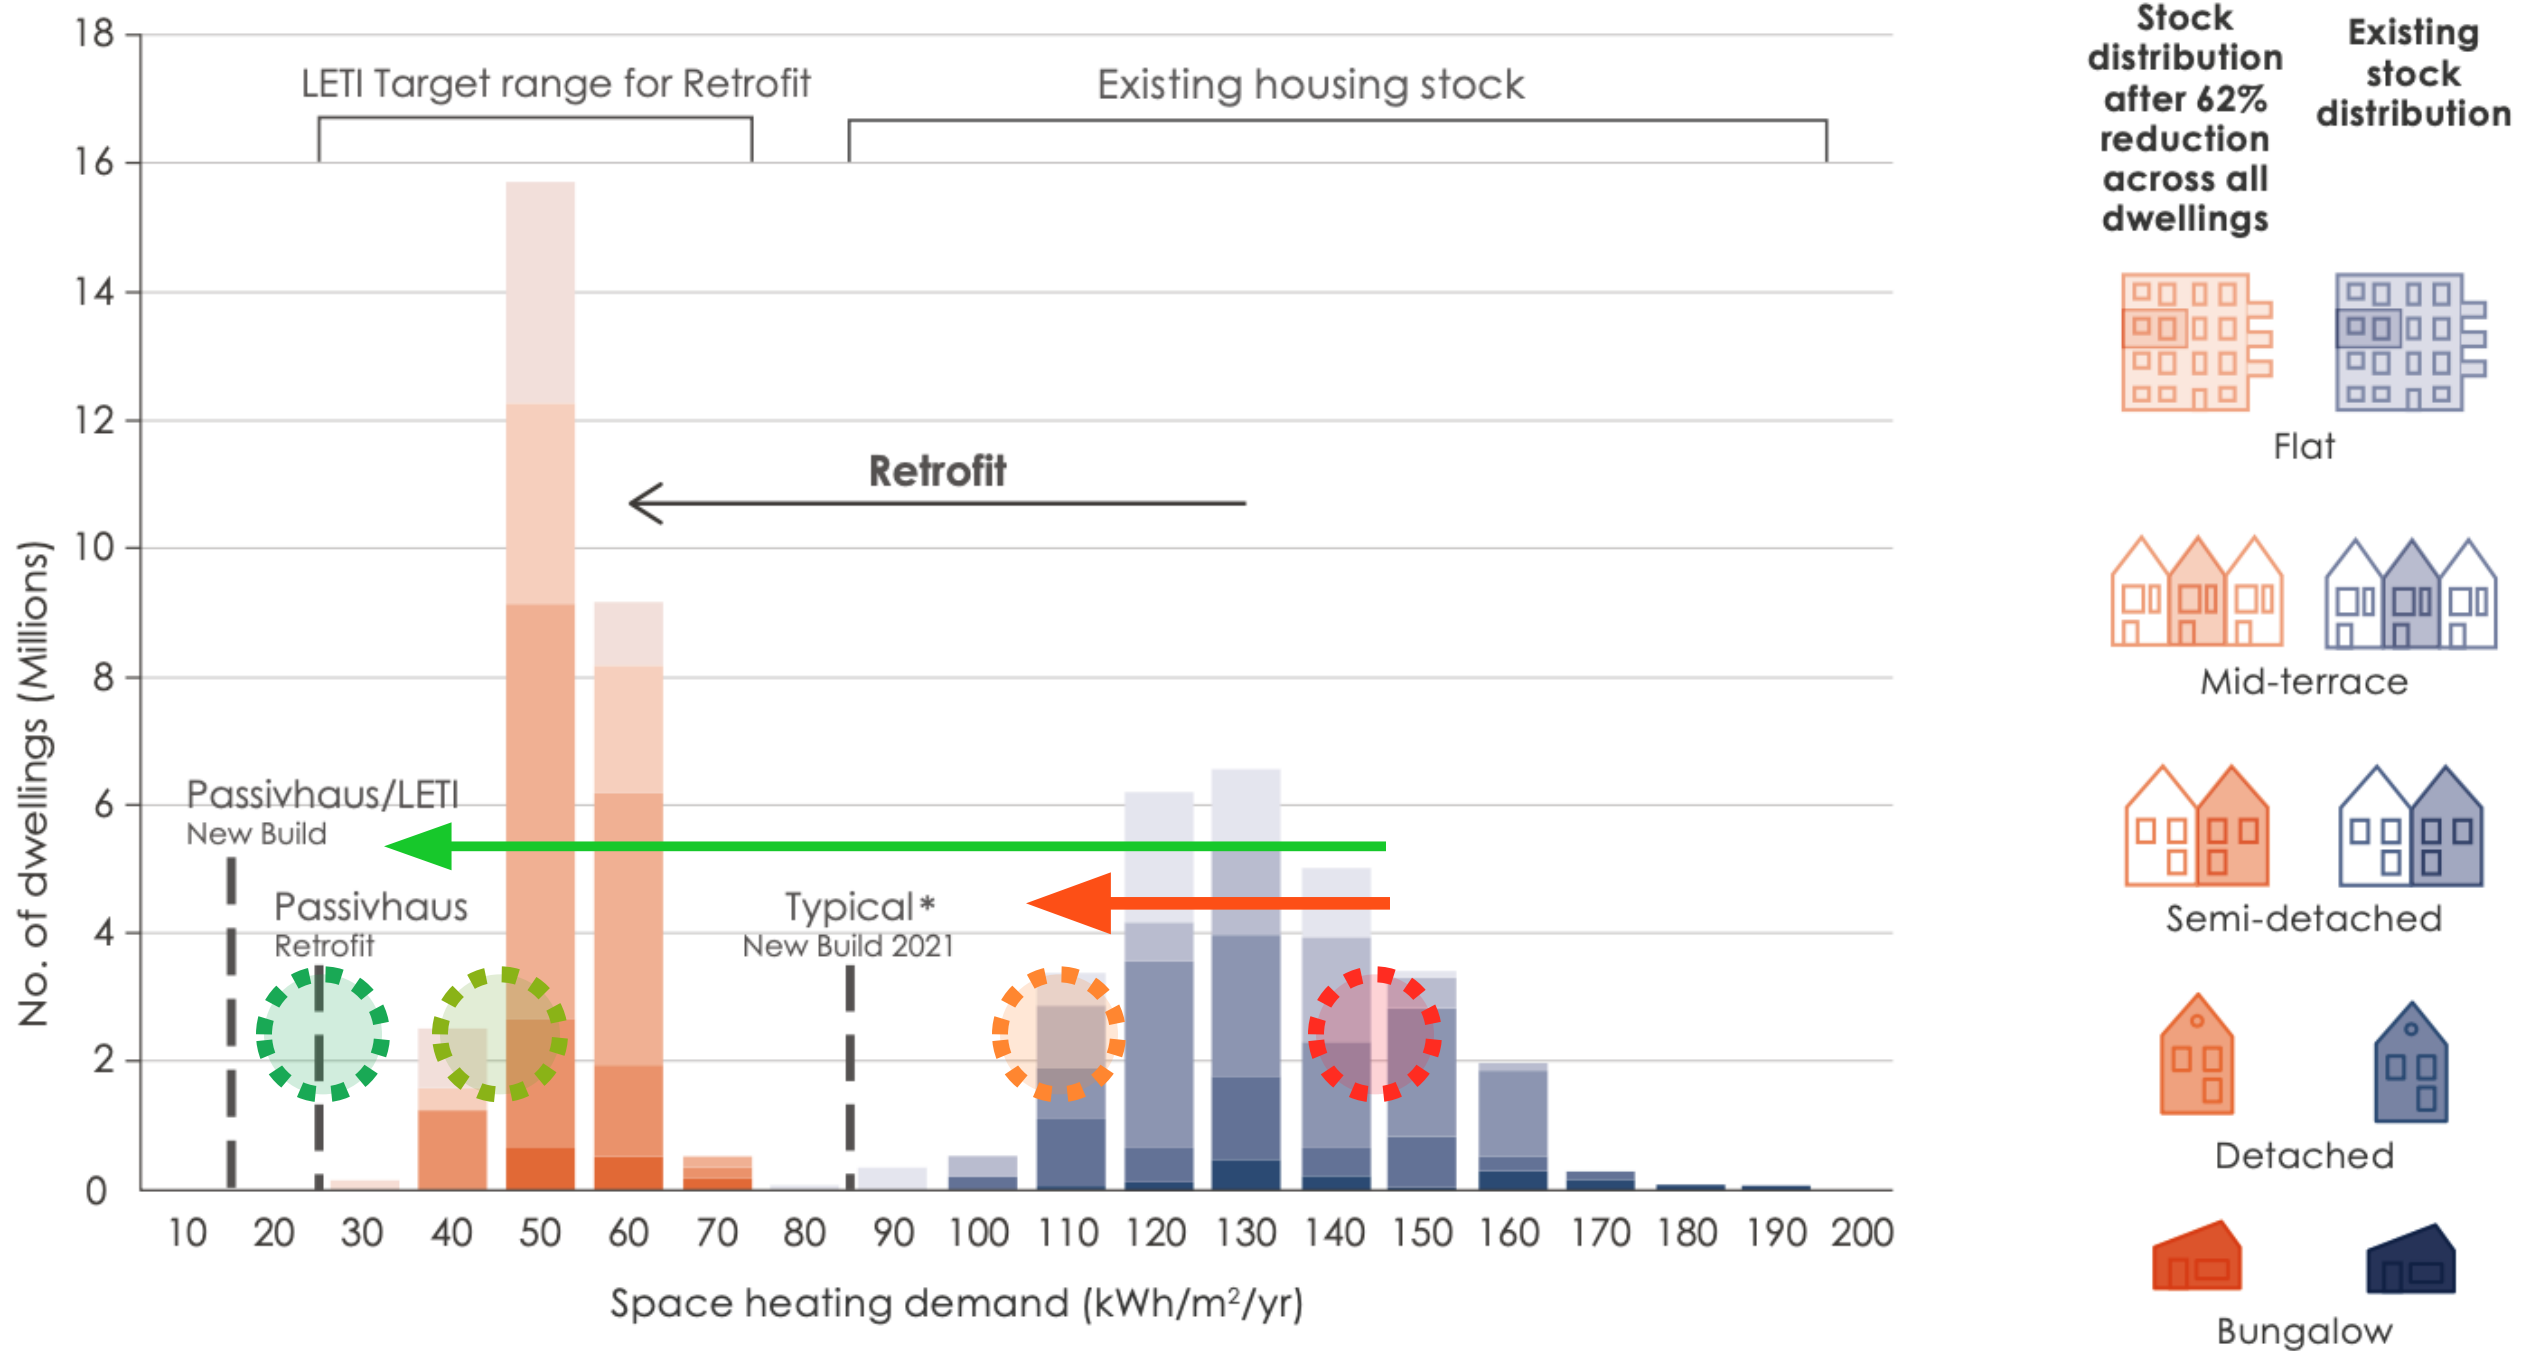
* Includes for an assumed performance gap

Figure 0.1 - Total number of UK dwellings broken down by their space heating demand, showing the transition required from existing levels of high demand to the LETI retrofit target range. Figure based on stock modelling carried out by LETI.

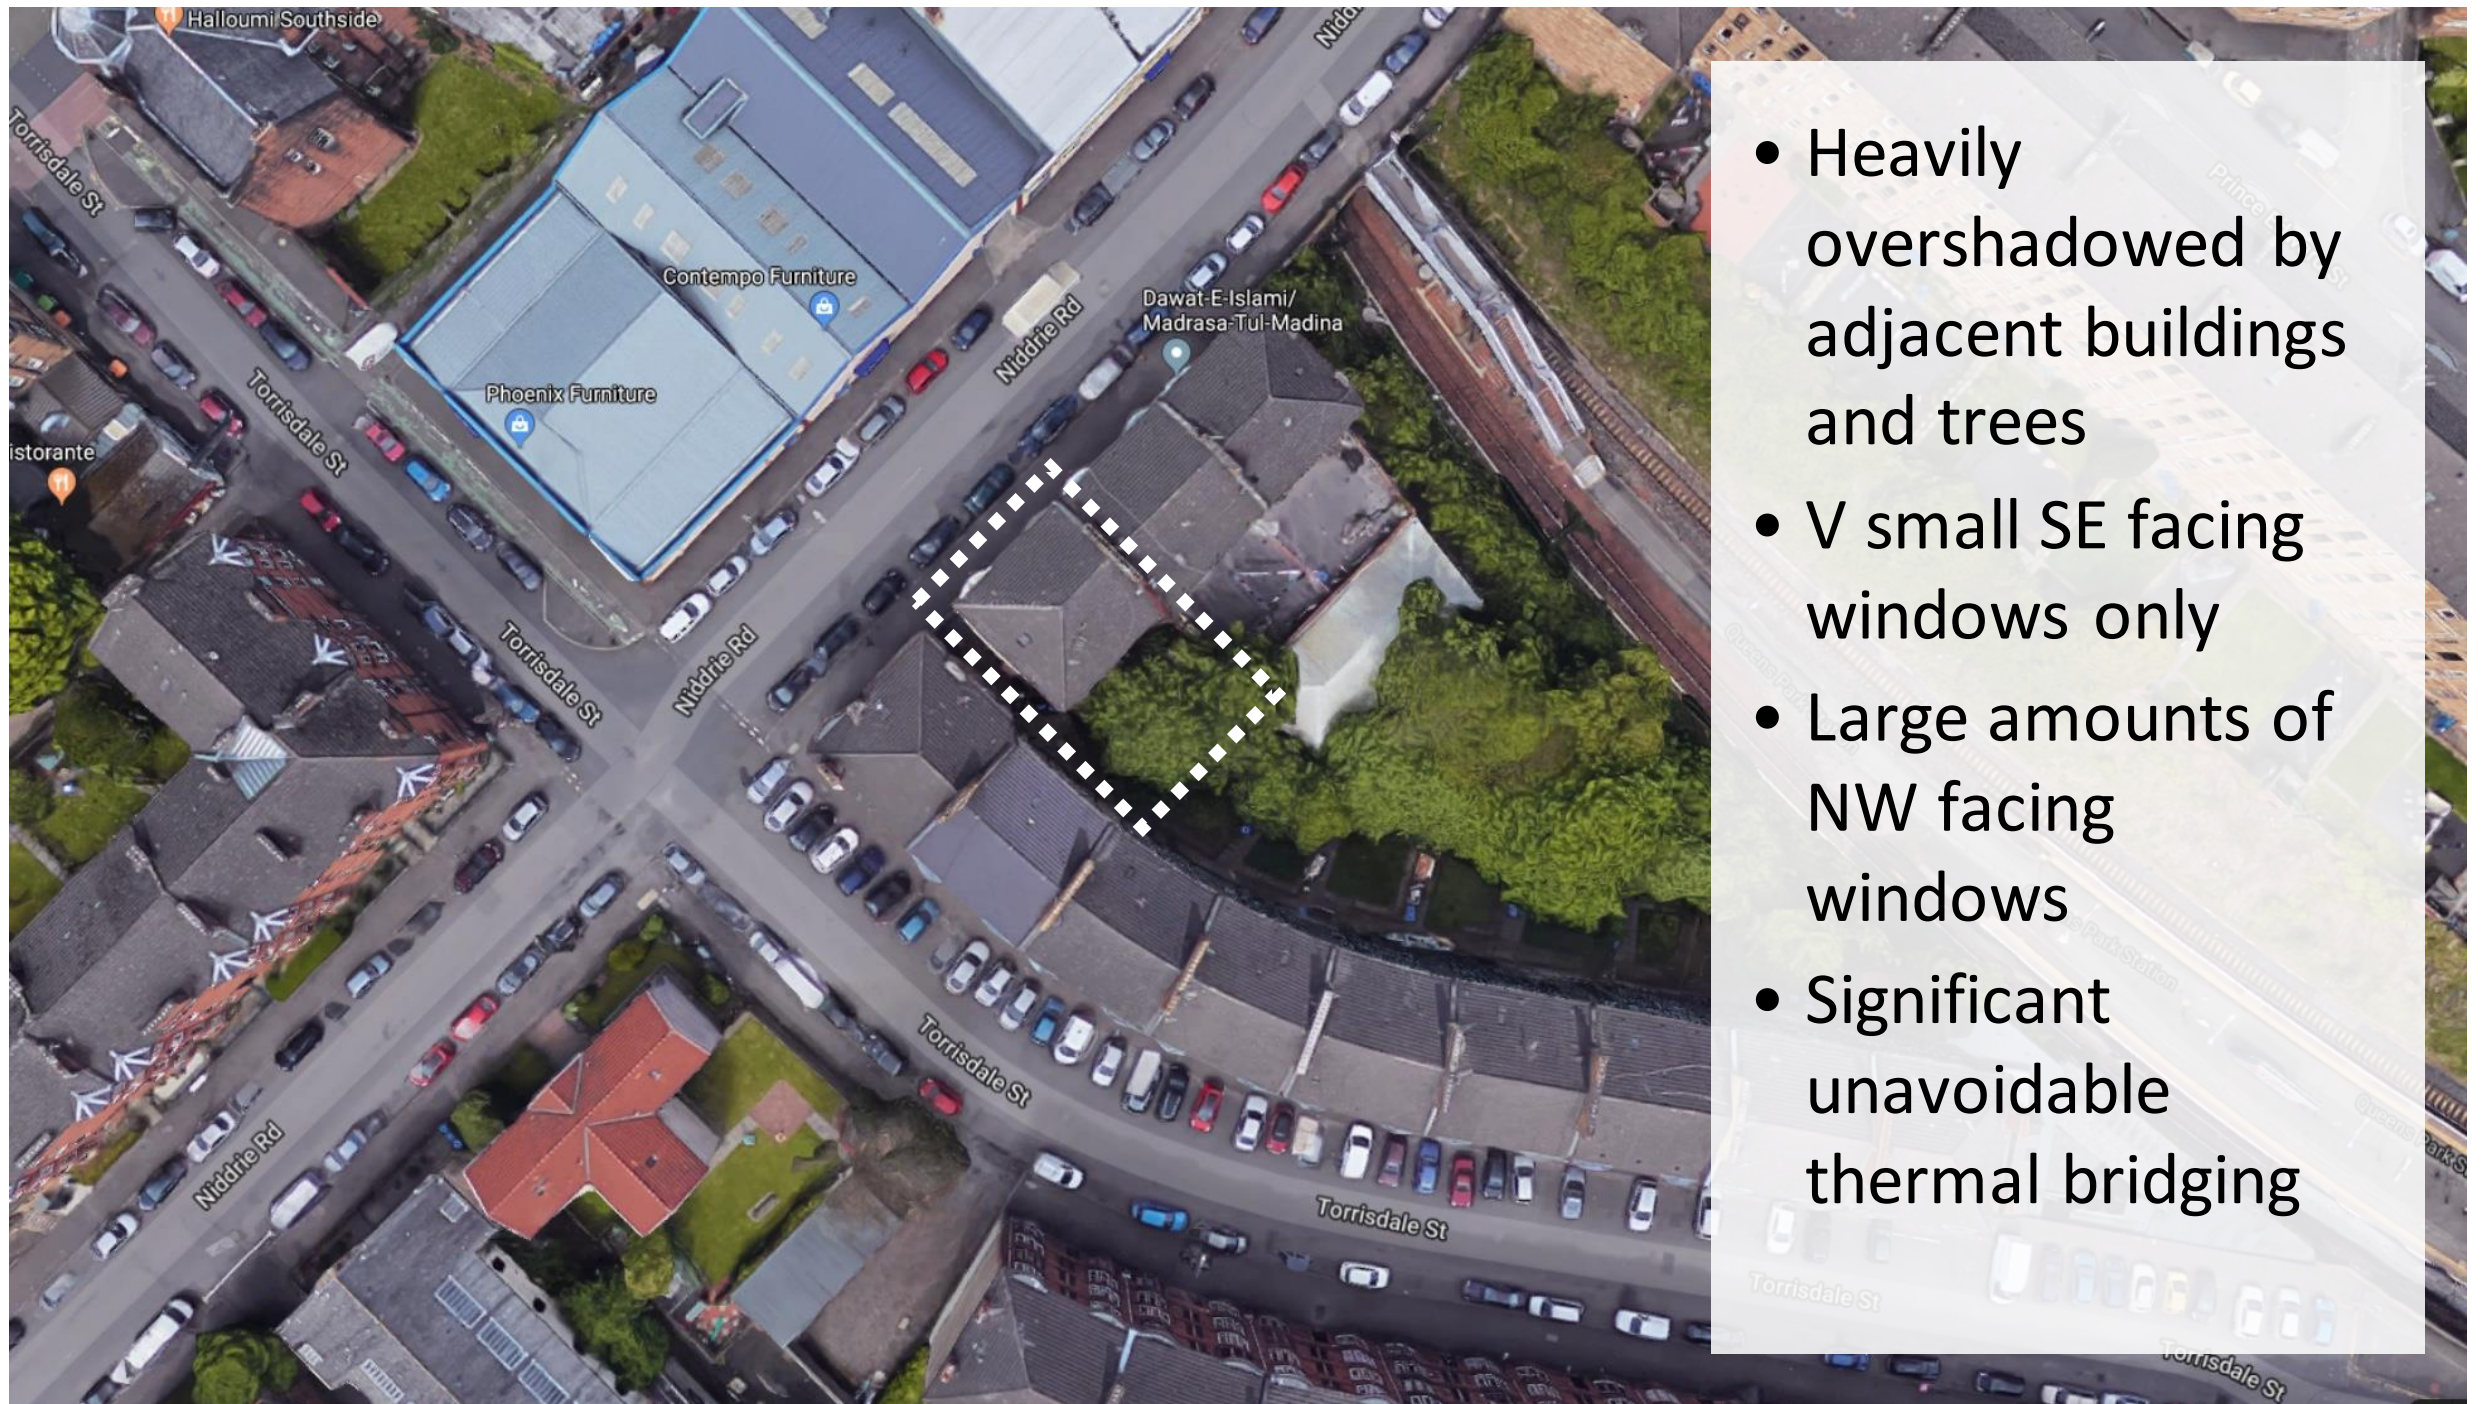
- Heavily overshadowed by adjacent buildings and trees
- V small SE facing windows only
- Large amounts of NW facing windows
- Significant unavoidable thermal bridging

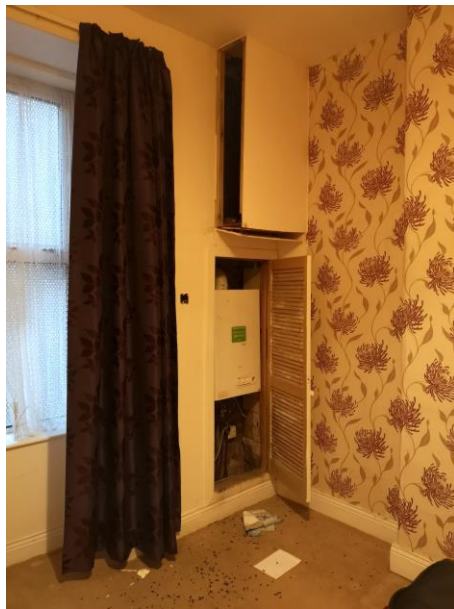
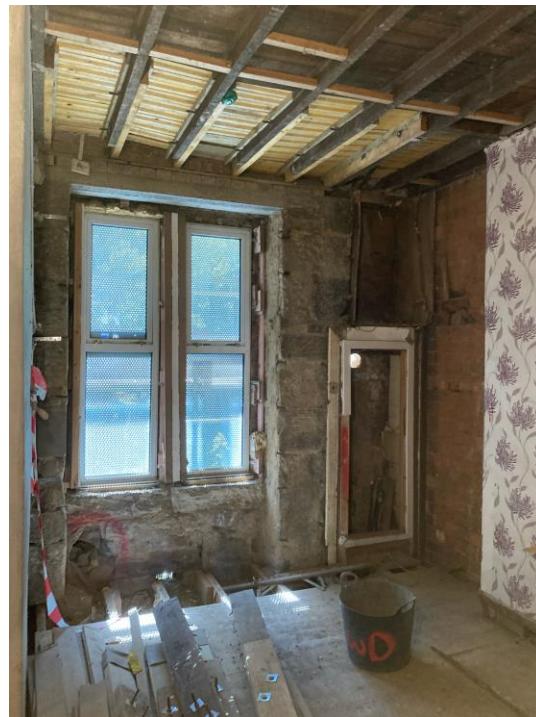
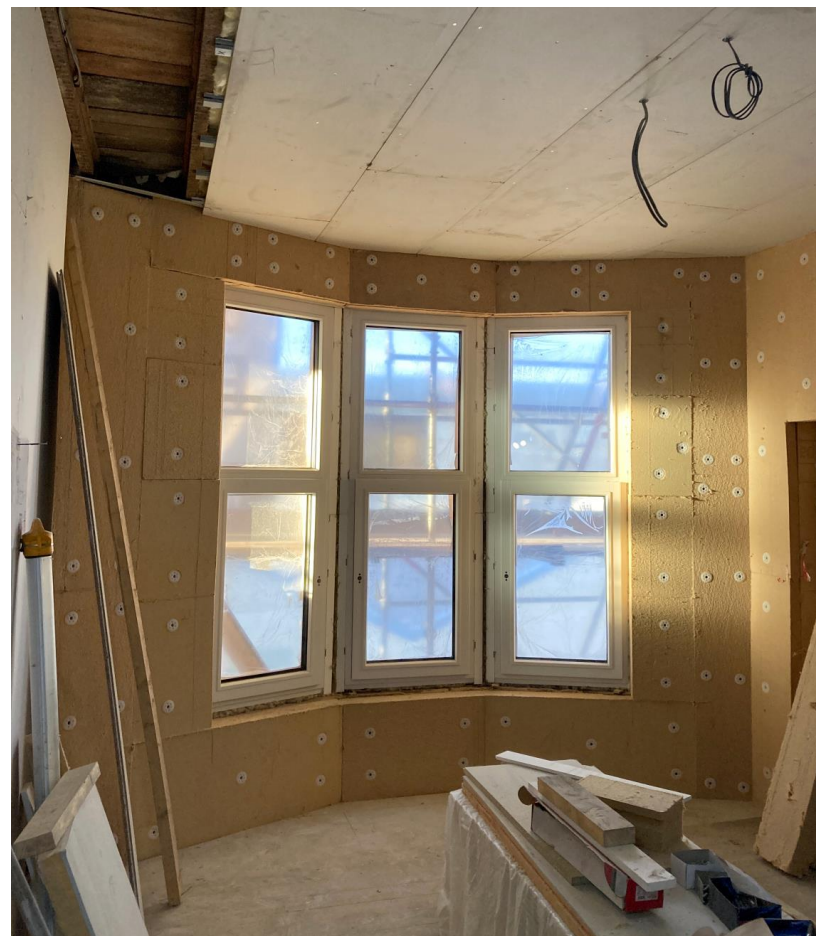
- Complete overhaul internally (full strip out including all services)
- Some urgent long-term maintenance (timber repair)
- EnerPHit energy performance + more holistic approach

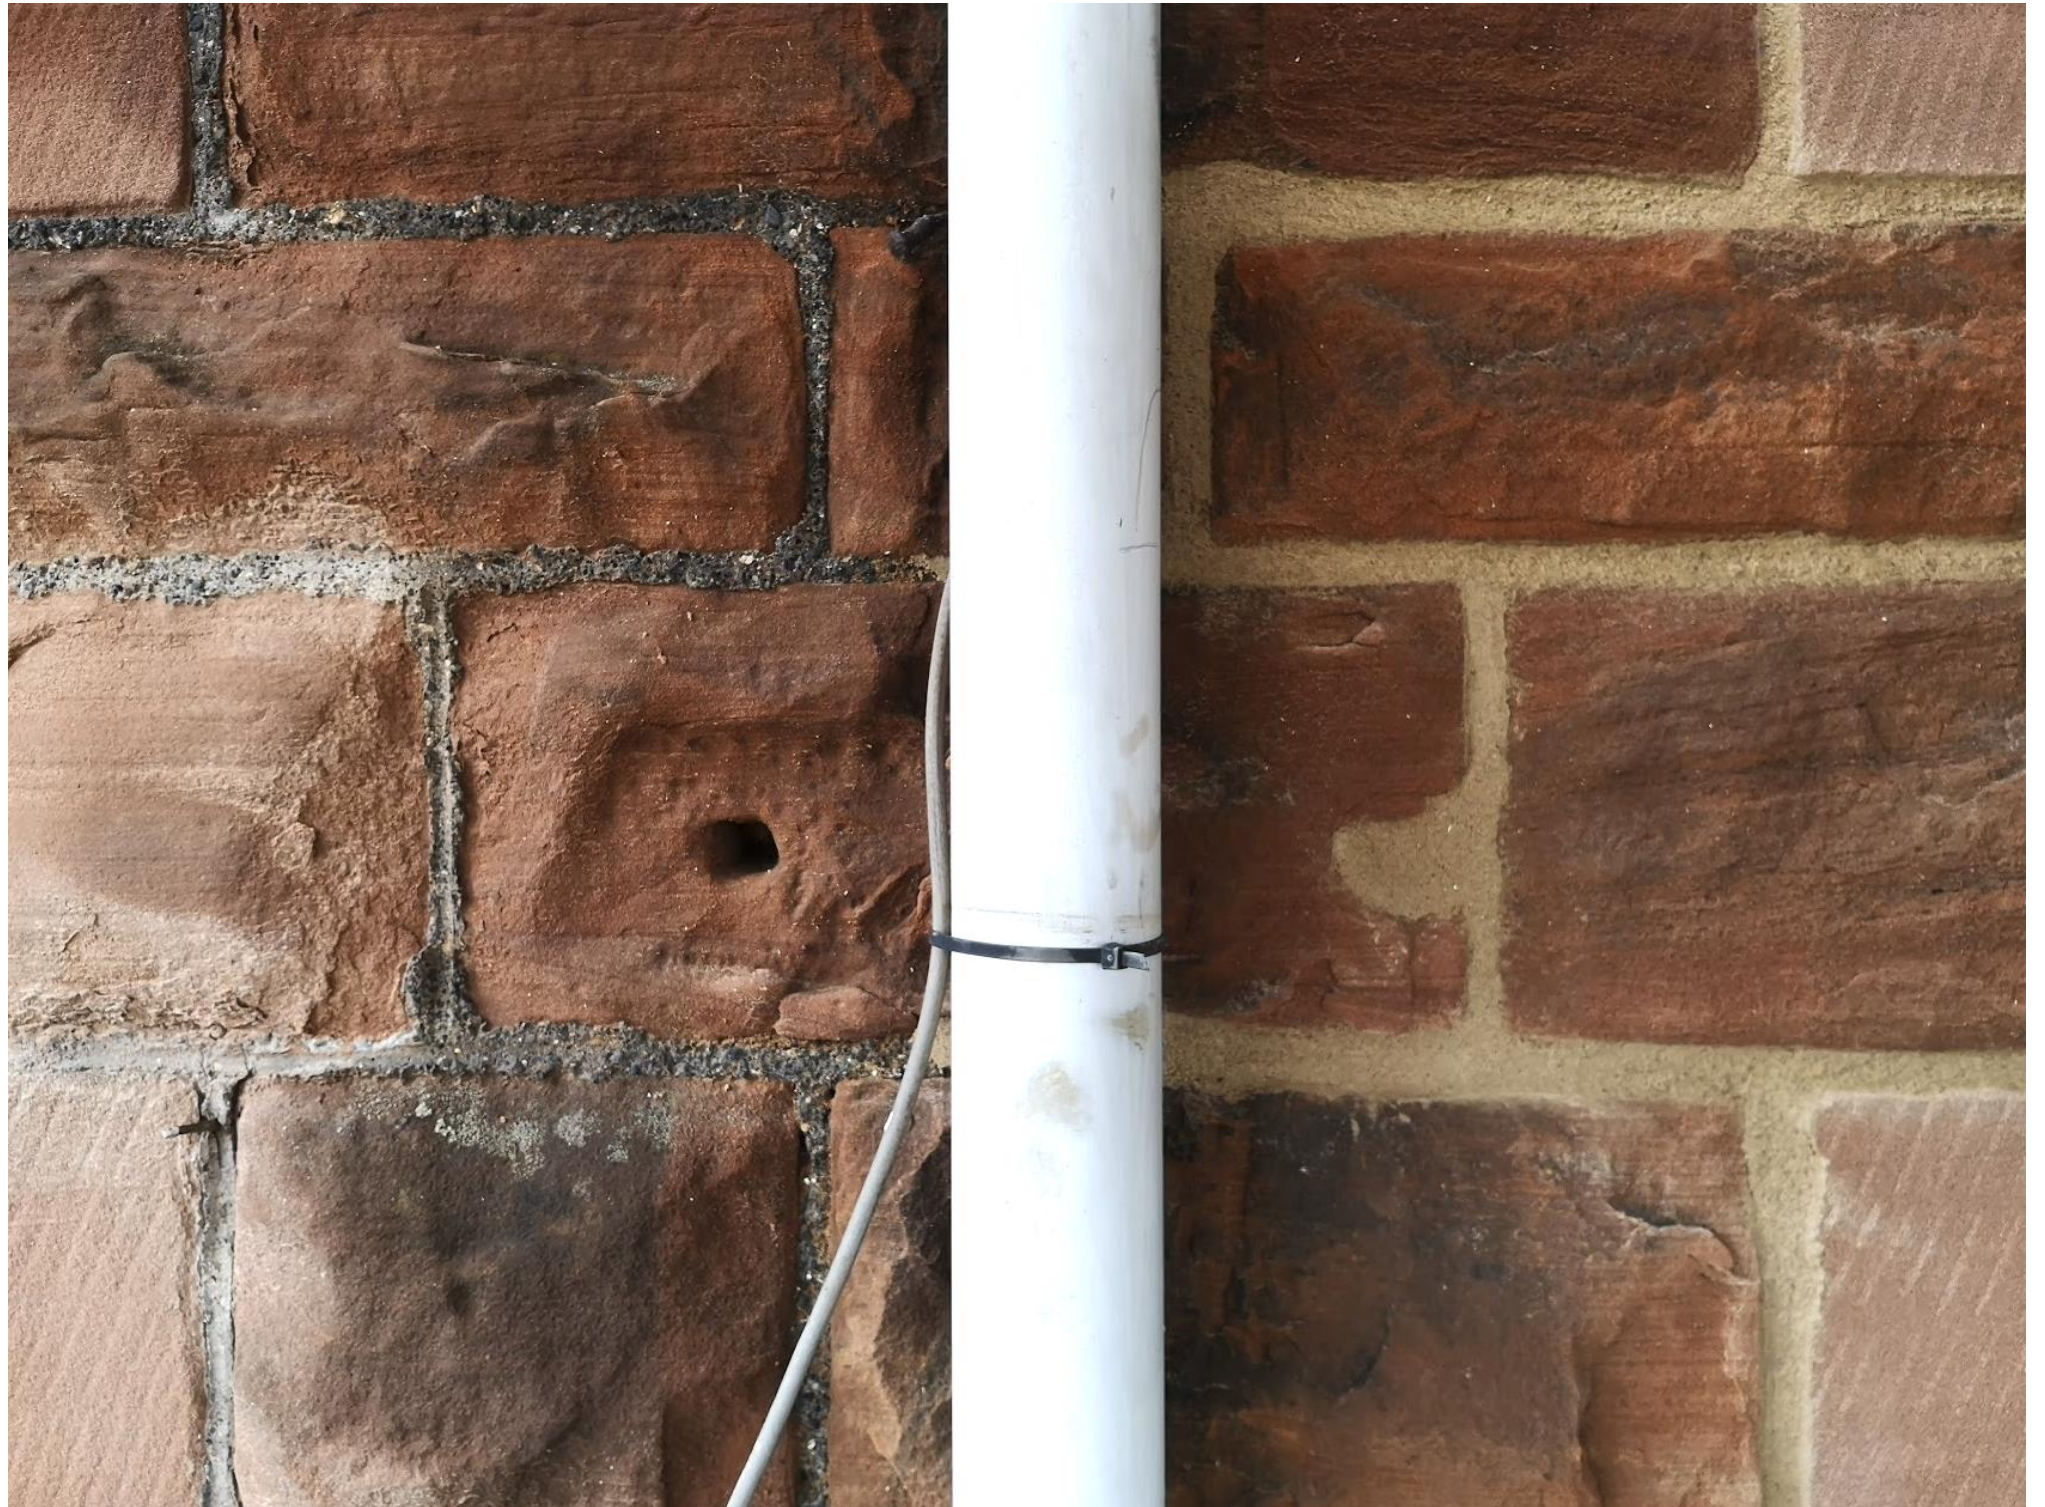
Niddrie Road Case Study - Masonry Repair

- DOFF cleaned
- Complete repointing in lime
- Stone replacement
- Lithomex repairs
- Keim painting of some areas

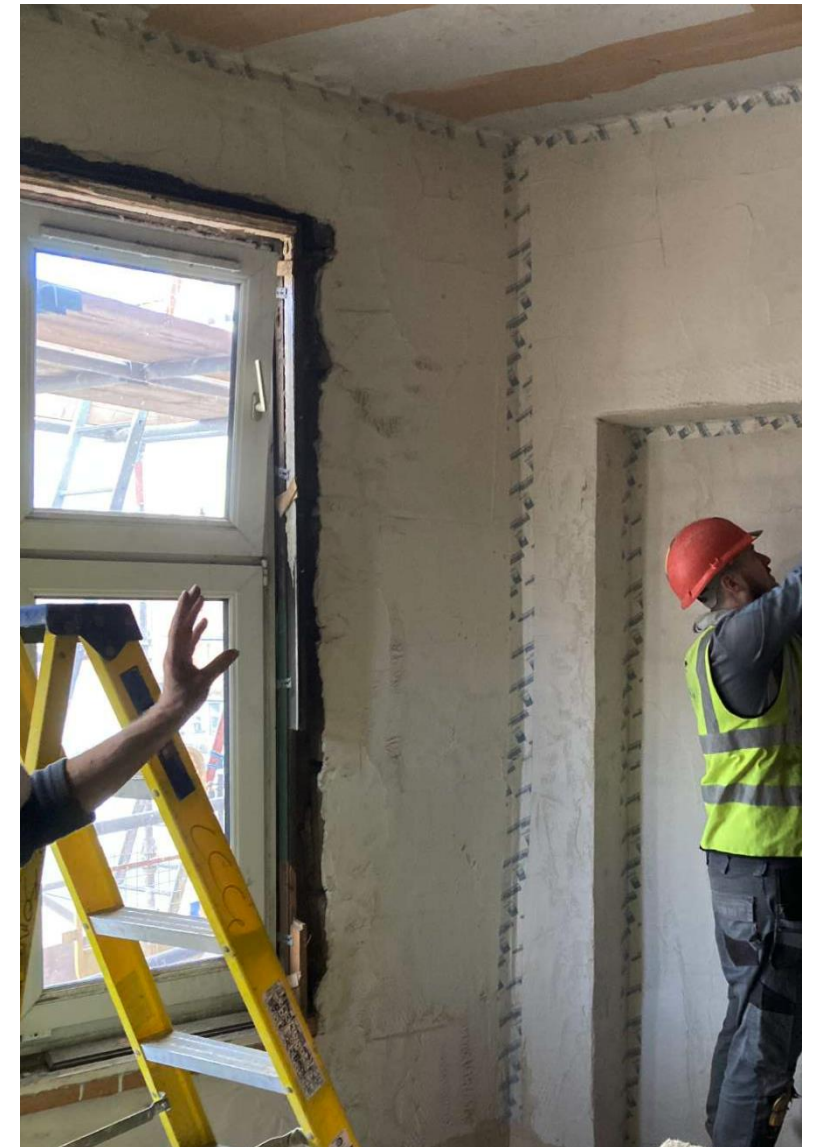
Niddrie Road Case Study - Airtightness + TG

- Airtightness
- Triple Glazing

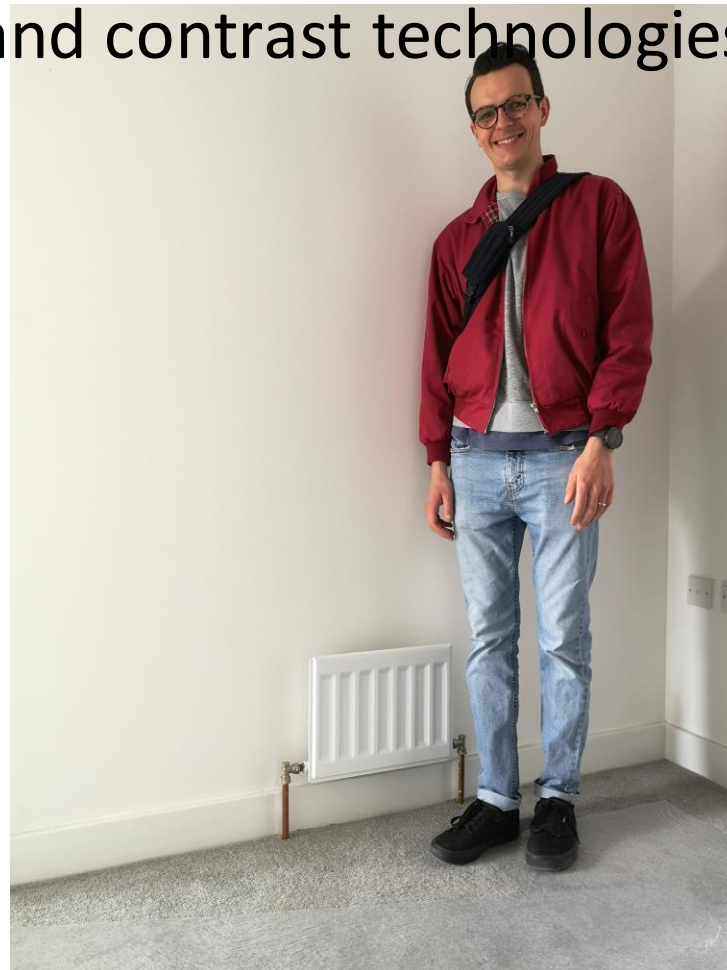
Niddrie Road Case Study - Heating

- Lower four flats have an Air Source Heat Pump (ASHP) installed
- Upper four flats have new energy efficient gas boilers
- Monitoring to compare and contrast technologies
